TAT ACTIVITIES REPORT  
PRELIMINARY SITE ASSESSMENT  
STANDARD STEEL AND METALS SALVAGE YARD  
ANCHORAGE, ALASKA

28 OCTOBER - 8 NOVEMBER 1985

Region X  
Technical Assistance Team  
TDD #10-8510-07

Region X  
Environmental Protection Agency

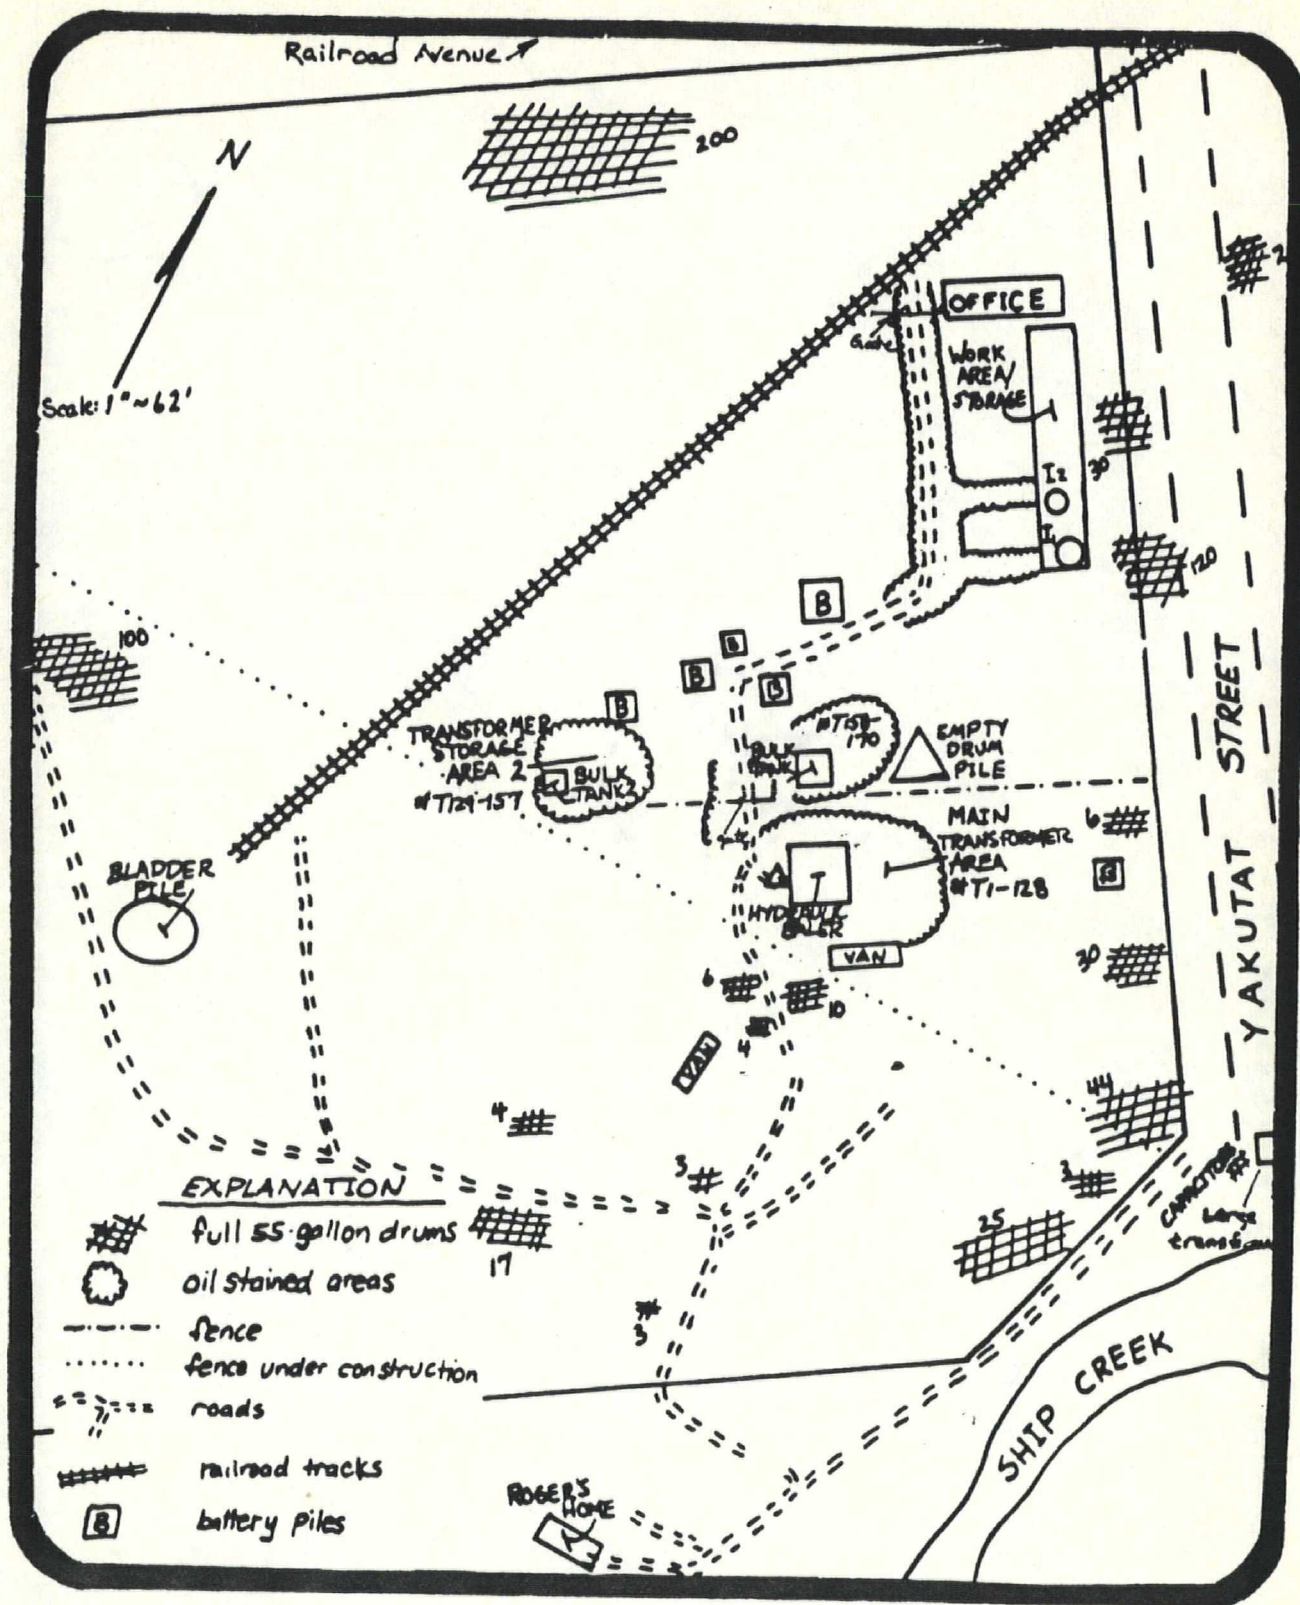
Figure 2

high piles of heavy metal debris. The only exposed soil is found along the one-lane unpaved roadways which wind throughout the site (Figure 2). Soils along these roadways were found to be oil-stained in several areas. Small pathways could be found winding through and sometimes over piles of debris. However, these pathways are usually quite narrow and expose very little area of soil for sampling purposes. TAT personnel had originally planned to set up a uniform grid network for soil sampling, however, after viewing the site it became obvious that this method was not possible. Another factor discouraging the use of a grid network was that items at Standard Steel are often moved to different locations on the site. Metal items are moved to new areas in order to gain access to salvageable objects. Instead of replacing the objects in the same location, new piles are moved to this area when another salvageable item needs to be uncovered. Items were often found in different locations daily. For example, one wooden pallet which contained three small cylindrical transformers was observed in four different locations during the two-week site assessment.

Site Diagram  
Standard Steel and Metals Salvage Yard  
Anchorage, Alaska

- o Transformer Storage Area #2 - Transformers were inventoried in a second storage area located approximately 20 feet northwest of the gate in the fence which borders the north side of transformer storage area #1 (Figure 2). Twenty-eight transformers were located in this area. EPA and ADEC personnel were not aware of these transformers, which were mainly the relatively large (over 200-gallon capacity) cubical type. Many of these transformers were stacked on top of each other and inaccessible to sampling personnel. The soil in this area was heavily oil stained. Sampling in this area was begun and completed on 4 November.

- o Transformer Storage Area #3 - A third transformer storage area, also unknown to EPA and ADEC personnel, was located in the area of the large bulk tank (Figure 2). Fourteen transformers were located in this area, 11 of which were found to be empty. The surrounding soil was again very dark and oil stained. In addition, this area contained charred trans-

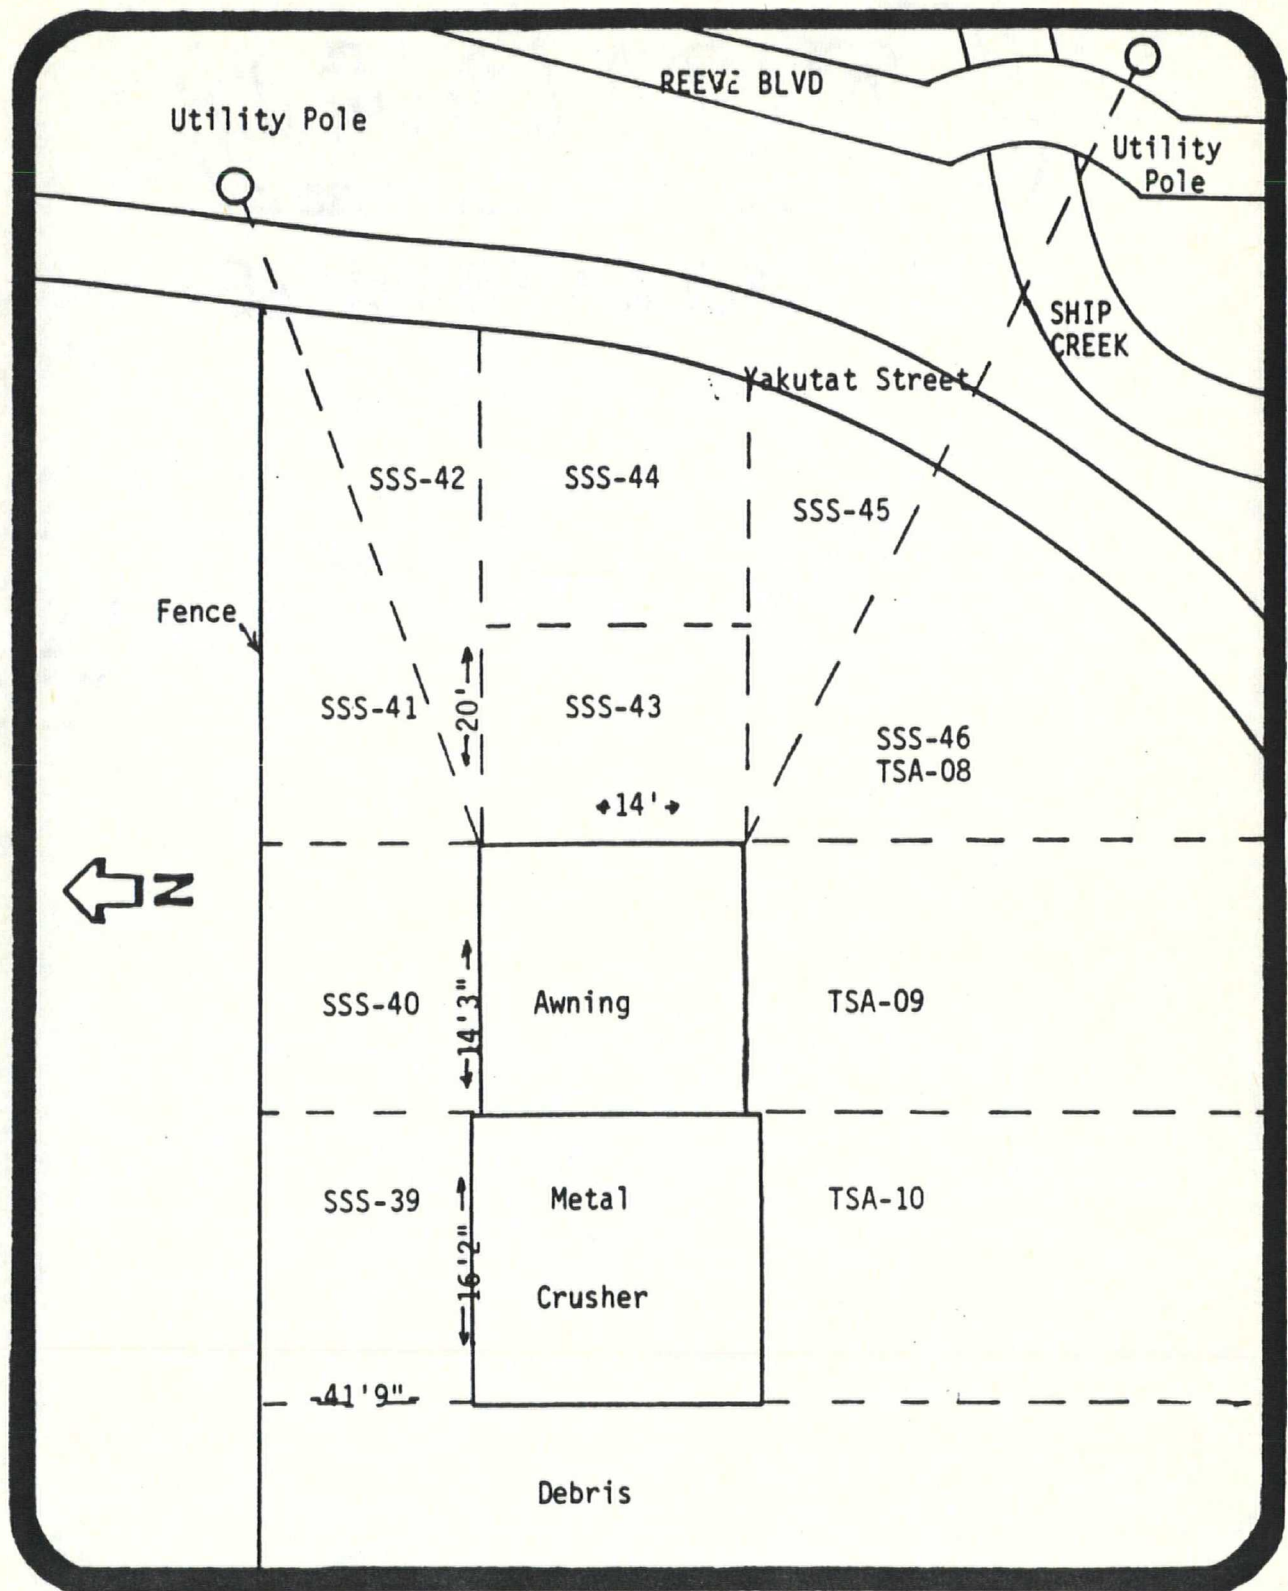
Figure 3

- o Transformer Storage Area #1 - A grid sampling network was set up for the collection of composite soil samples from this area (Figure 3), and 11 composite soil samples were collected for PCB analysis. One sample was also analyzed for carrier solvents, phenols, and heavy metals. The ADEC samples which indicated 110,000 and 87,000 ppm PCB had been collected from this area. TAT personnel attempted to collect soil from each oil-stained area of soil within a section; however, the majority of the soil in the area appeared to be oil-stained.
- o Transformer Storage Area #2 - Two composite soil samples were collected from transformer storage area #2. The distance from the roadway (which forms the northern boundary of this area) to the fence (which forms the southern boundary) was divided in half and a composite sample was col-

Sampling Grid  
Main Transformer Storage Area  
Standard Steel, Anchorage, Alaska

- o Transformer storage area #1 indicated significant PCB contamination. Values ranged from 87.0 to 165,000 ppm. The 165,000 ppm sample was collected from the same area as the 110,000 ppm soil sample ADEC collected on 5 August 1985. The areal surface of this transformer storage area is approximately 100 feet by 100 feet. It is unknown as to what depth contamination has migrated into the soil. It should be noted that a shallow aquifer is reported to exist at approximately 15 feet below the ground surface.
